SUBJECT: CFORCE 400/500 Rear Gearcase Replacement

VEHICLE(S) AFFECTED: MY2021 CFORCE 400/500 ATVs (606 VINs)

ISSUED: October 12, 2021

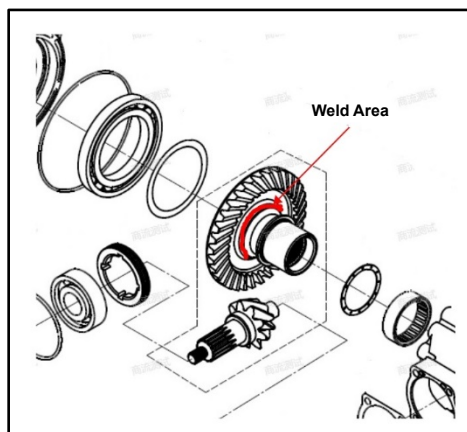
CFMOTO has identified a potential for rear gear case failure on a select number of MY2021 CFORCE 400 and 500 ATVs due to a welding process error at the base of the ring gear. A limited number of ATVs are affected.

MANDATORY Bulletin WAR-2021-07 has been issued for replacement of the rear gear case assembly on the select vehicles. This bulletin is required to be performed on the affected vehicles before they are sold, or at the first service opportunity if already sold.
